Maryland Inventory of Historic Properties Form

Survey No. CE - 362

historic J. M. Peterson Property

Inventory Number: CE - 362
J. M. Peterson Property
Cecil County, MD
C. Mazurek
June 1998
Section 7.1

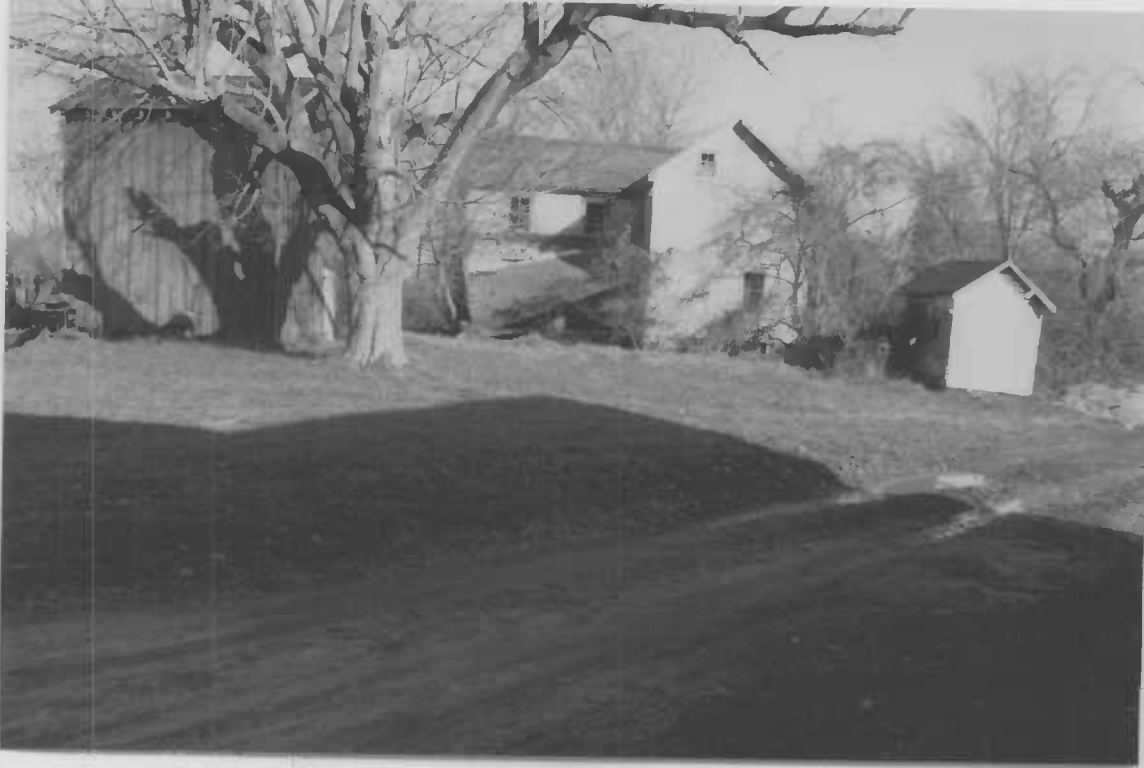
The farmhouse is two and one-half stories tall, with a size of three-bays by two-bays wide. Overall it is a typical late Nineteenth century farmhouse with an "L"-shaped, rear-facing, plan. Within the center of the "L" is an open side porch, while the front facade has a full length open porch. The foundation is constructed of fieldstone, with a covering of concrete over the surface. Upper stories consist of wood frame construction with an exterior covering of lapped horizontal clapboard. The roof over the main section is side-gabled with a covering of replacement composition shingles. Three interior, brick, ridge chimneys flank each gable of this structure. Windows on the front facade are 6/6, while on the rear facades there are 2/2 sash windows.

The storage shed and cistern house are parallel to the farmhouse, and are roughly the same age. They are one-story structures that are one room wide. They are built of wood frame construction, on a stone foundations, with exterior coverings of wood, lapped, horizontal clapboard. The roofs have a covering of replacement composition shingles with exposed rafters on the eaves.

All of the structures are in excellent condition, with the exception of the farmhouse. It has lost the entire front of the facade, roof and wall included. Vegetation is beginning to overtake the structure and both porches have fallen off.

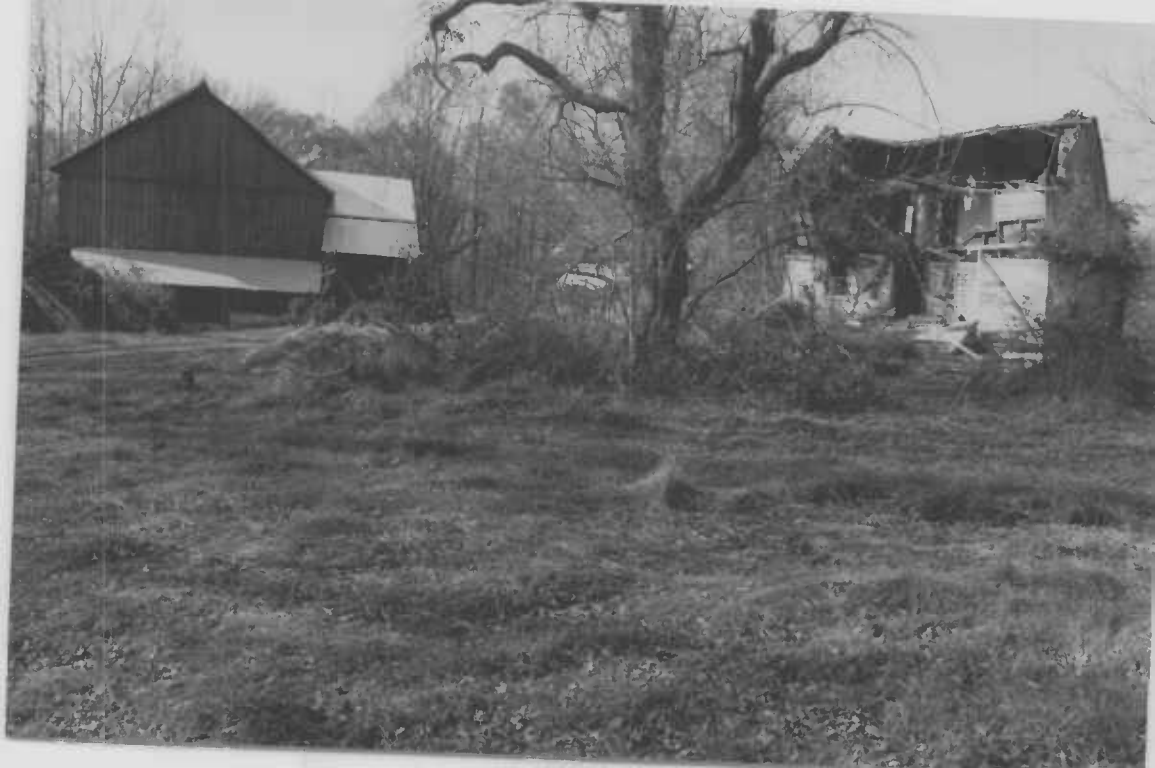
The bank barn has a uncut, uncoursed, fieldstone foundation with wood upper stories and an exterior covering of vertical clapboard. The roof has a standing seam tin covering.

WEST VIEW OF BARN
